Report of Findings

STRUCTURAL EVALUATION

Claim No: 1002259499

Re: STRUCTURAL EVALUATION-314 E. 8TH ST.-CUSHING OK

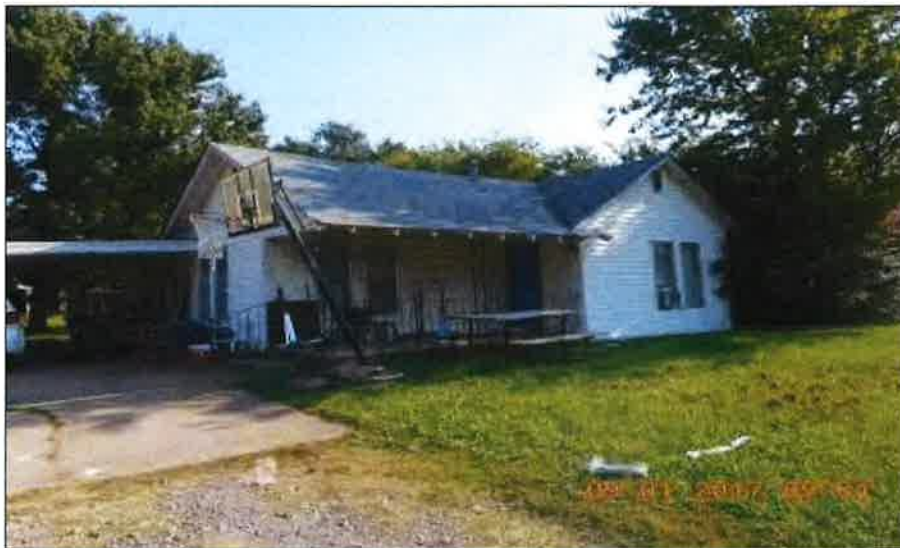
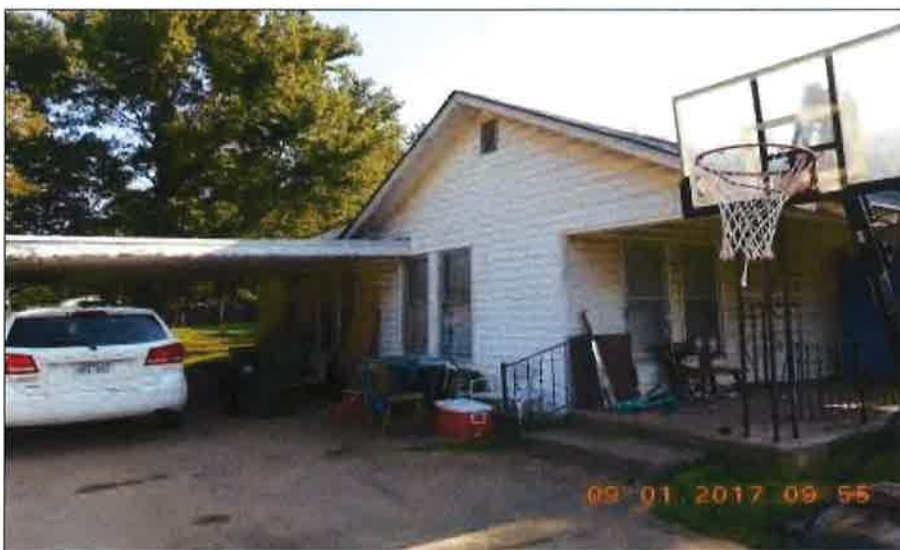
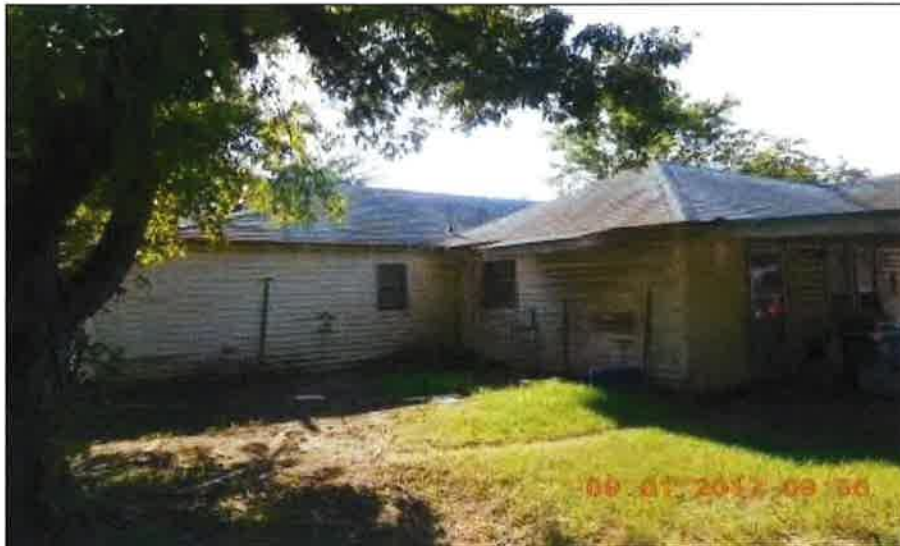
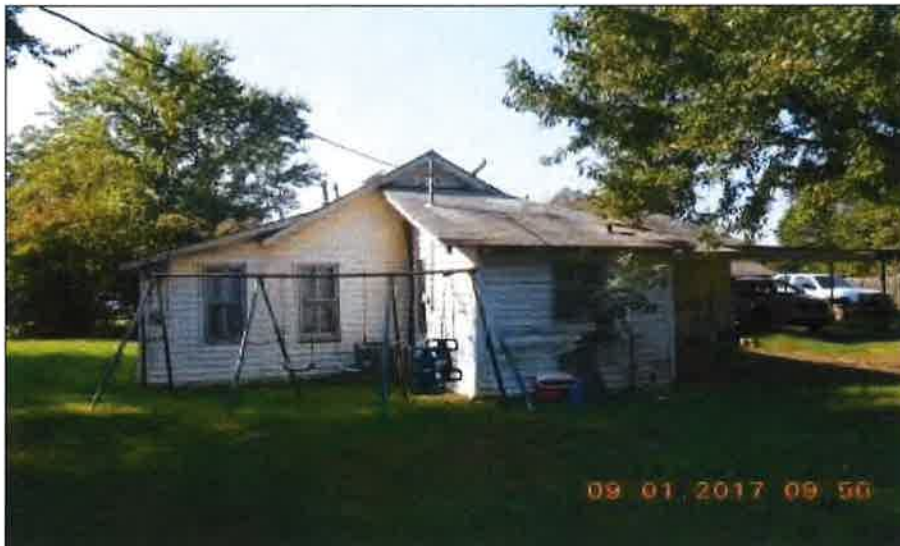
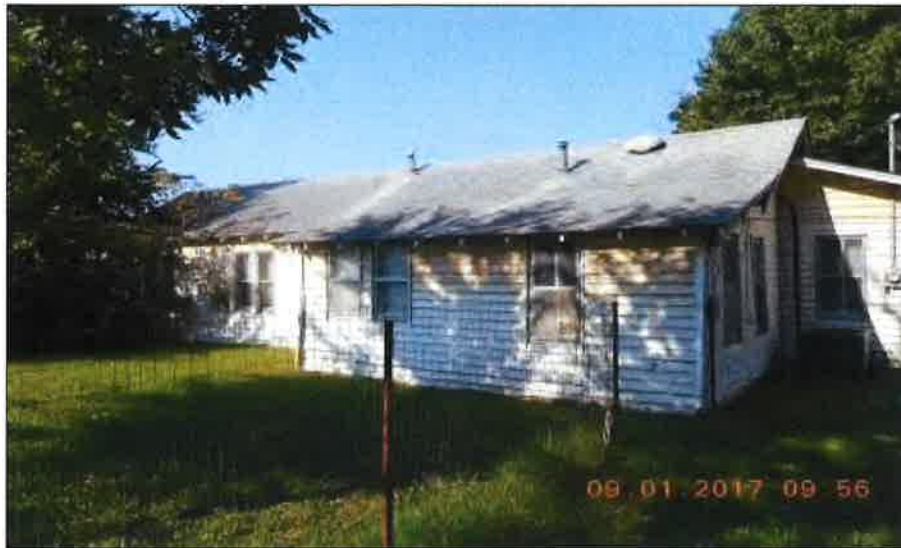
The residential property was a one-story, wood-framed dwelling covered with vinyl siding on the exterior. The foundation was a combination shallow foundation perimeter walls of an unknown material with portions of concrete slab foundation added later. The interior wall finishes were a combination of lath and plaster and drywall with paint. The ceiling was furring strips with acoustical ceiling tiles. The flooring was a combination of carpet and vinyl flooring. The roof covering was asphalt shingles. For the purposes of this report, the side of the residence with the front entrance door faces south, refer to (**Photographs 1 through 5**).

Photograph 1
South side.

Photograph 2
Front east side.

Photograph 3
Rear east side.

Photograph 4
North side.

Photograph 5
West side.

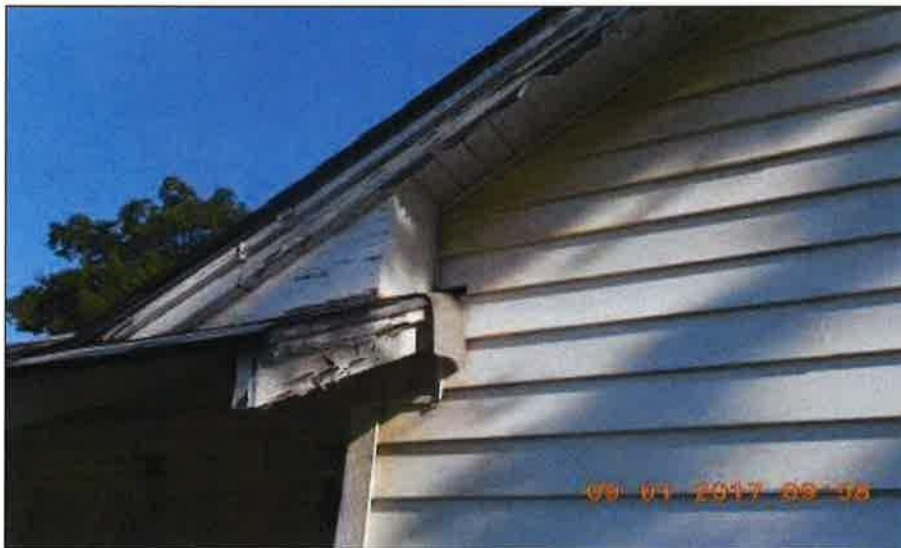
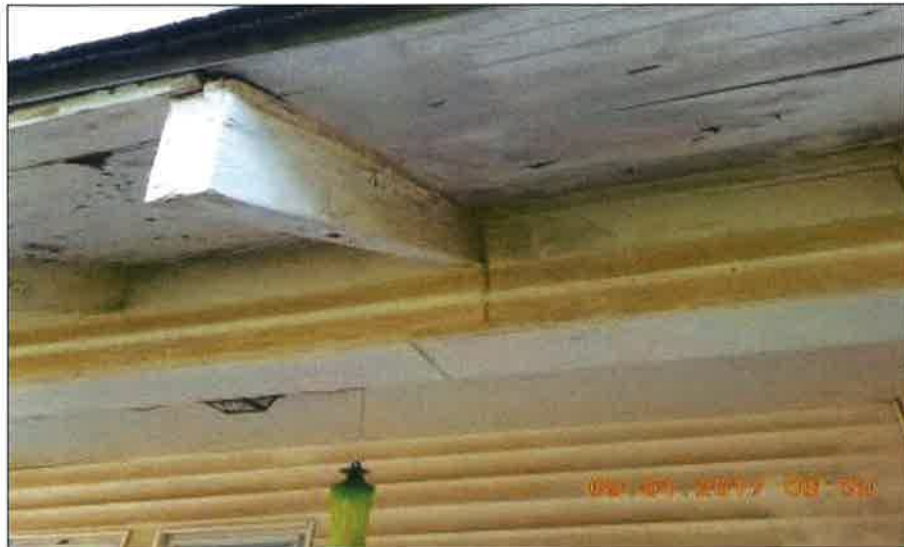
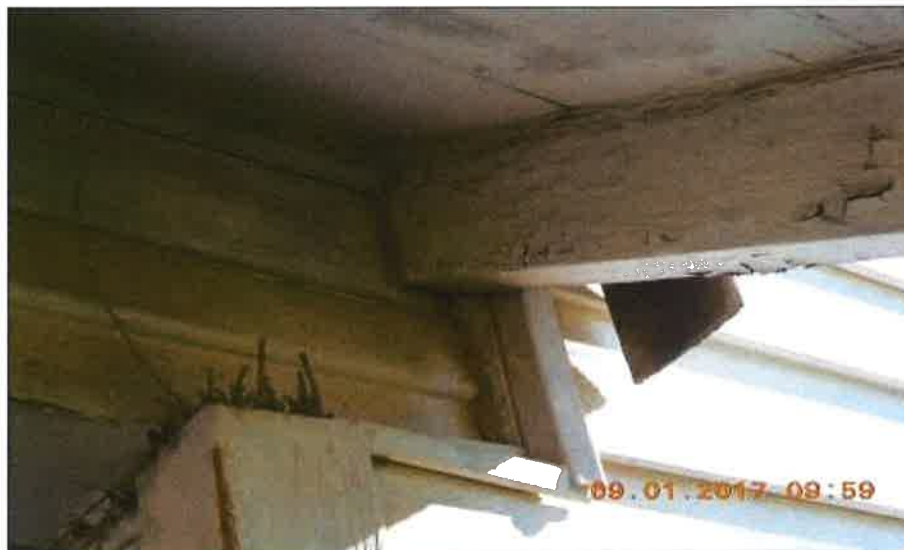
- The roof rafter connections to the wall framing were observed to be intact and without separation. Roof framing locations that did have cracks or separations were observed to have dust and cobwebs within the separations (**Photographs 6 through 8**).

The uneven floor was determined to be caused by differential foundation movement. The crack along the wall and leaning wall were determined to be caused by a poorly constructed floor extension consisting of an added footing adjacent to an interior slab. Other interior cracks showed signs of age and contained no stretched or cracked paint. The residence was out of plumb in several locations with the cause being differential foundation movement. Horizontal cracks were observed in the driveway slab and the front porch. These cracks showed signs of age and were consistent with shrinkage cracks and differential foundation movement cracks. Furthermore, cobwebs and insect nests were observed in several of the separations indicating they were not recently formed.

Photograph 6
Roof connection.

Photograph 7
Roof connection.

Photograph 8
Roof connection.

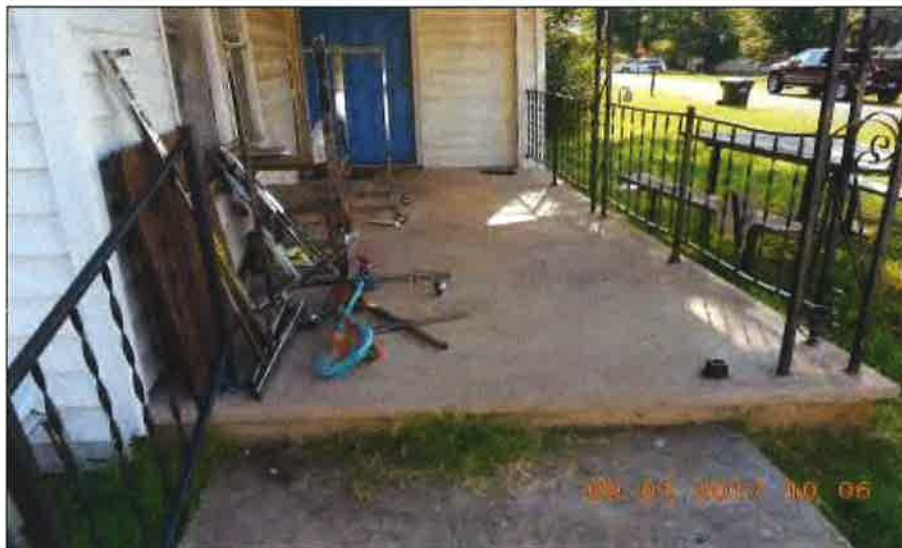
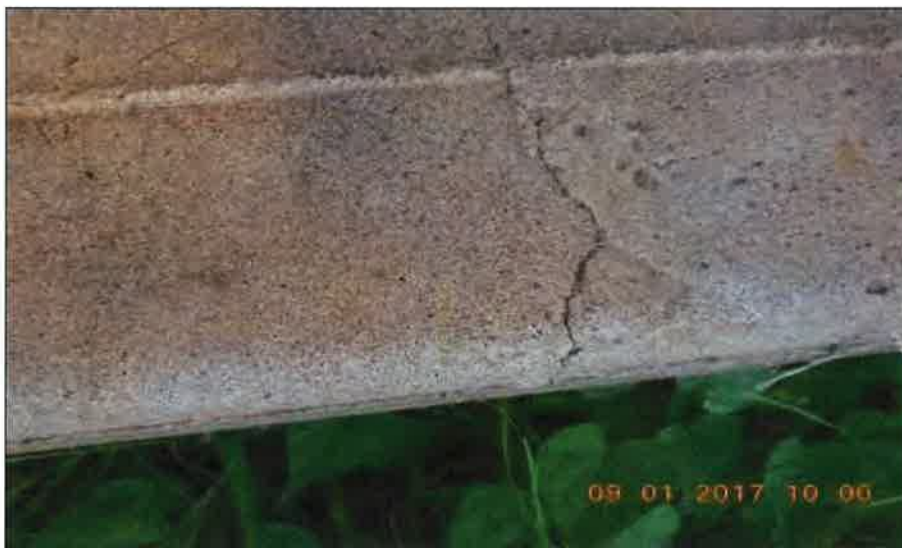
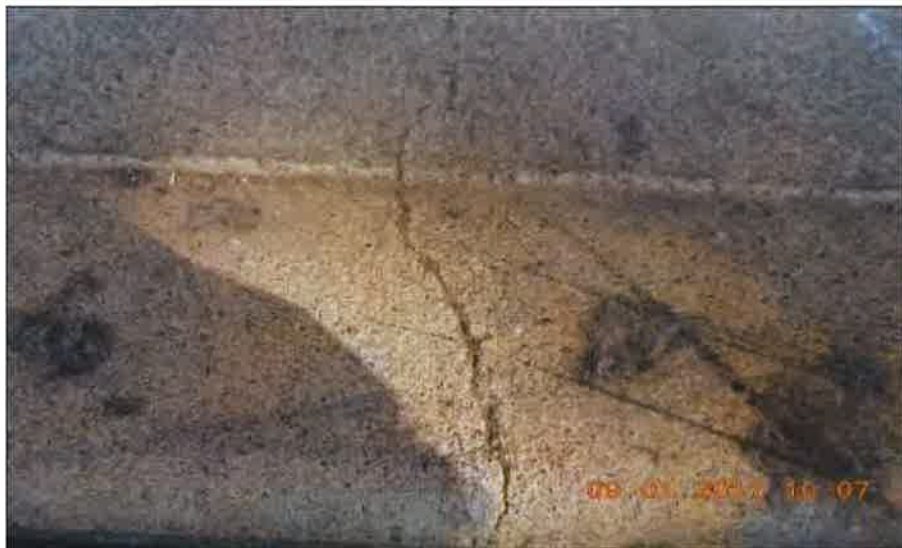
- The slab supporting the front porch contained cracks. The stem wall was covered by the vinyl siding (**Photographs 9 through 11**).
- Cracks existed in the driveway slab under the carport. The cracks contained dust and showed wear over time along the edges of the cracks. (**Photographs 12 through 14**).

Photograph 9
Front porch.

Photograph 10
Front porch crack.

Photograph 11
Front porch crack.

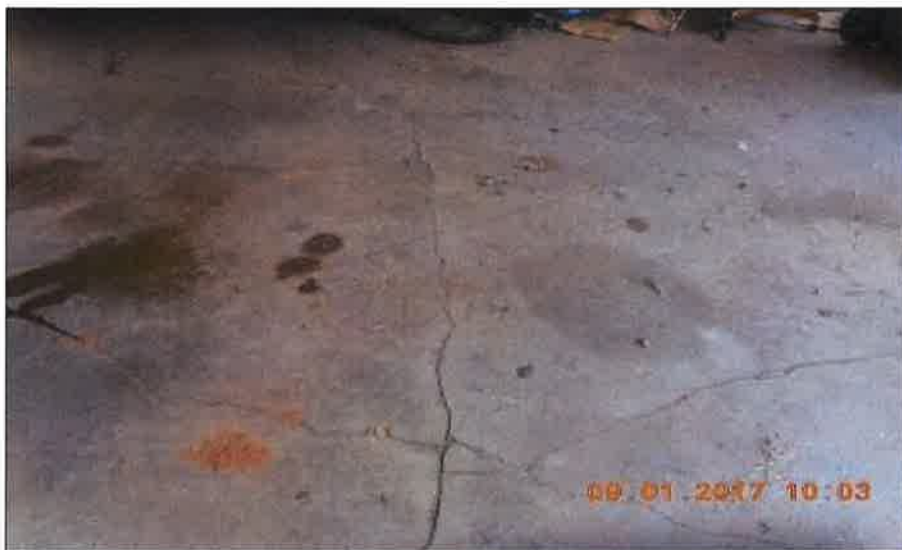
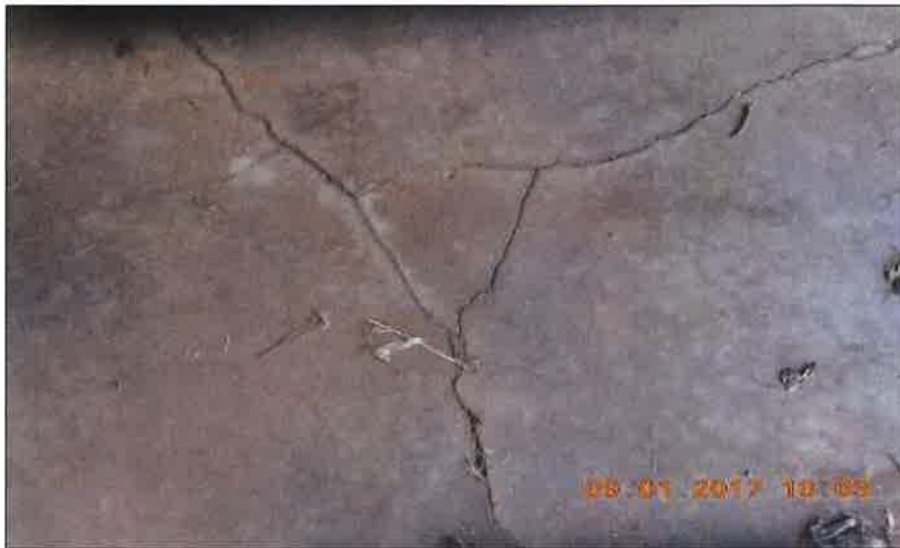
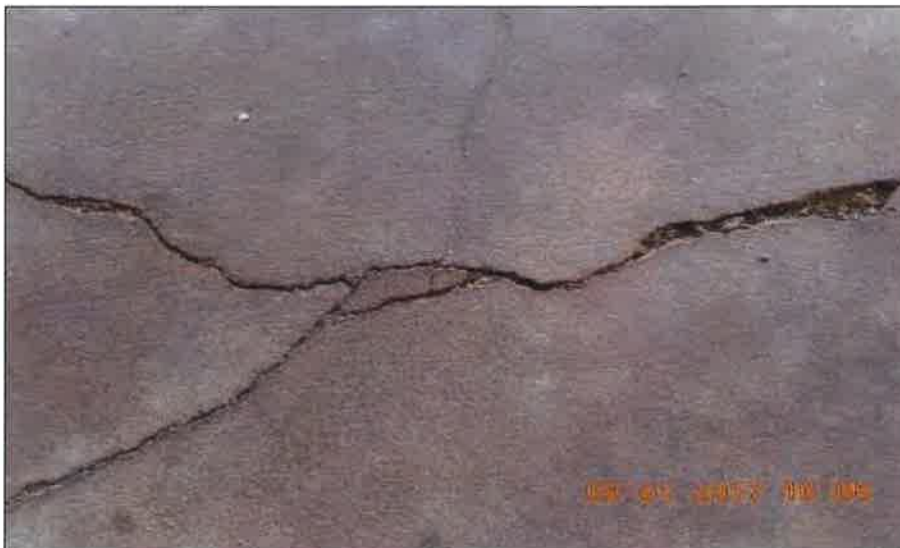
The origin of the damage observed to the floor, ceiling tiles, and driveway slab under the carport was from differential foundation movement related to volumetric soil changes from soil moisture variations over time. This is shown by the floor elevations that demonstrate variation in ground movement over an extended period of time. Poor construction techniques found at the foundation contributed.

Photograph 12
Driveway crack.

Photograph 13
Driveway crack.

Photograph 14
Driveway crack.

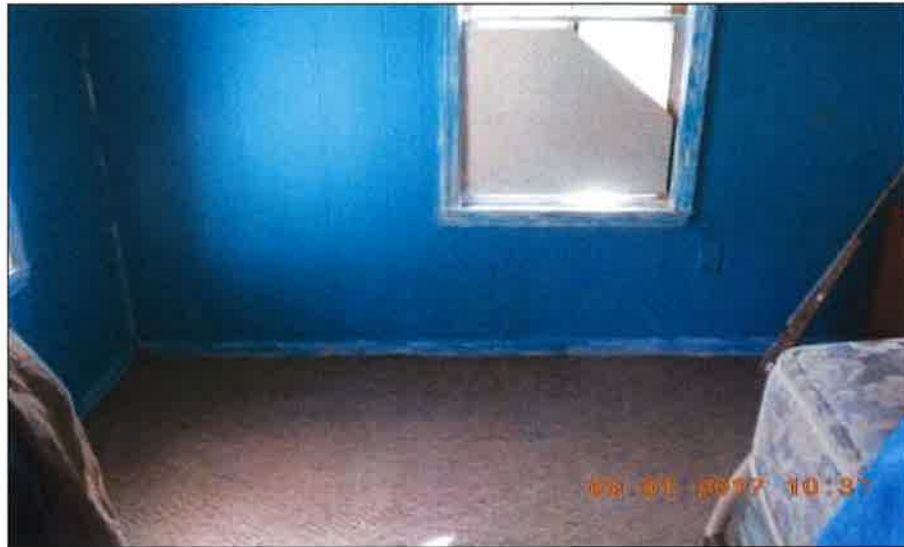
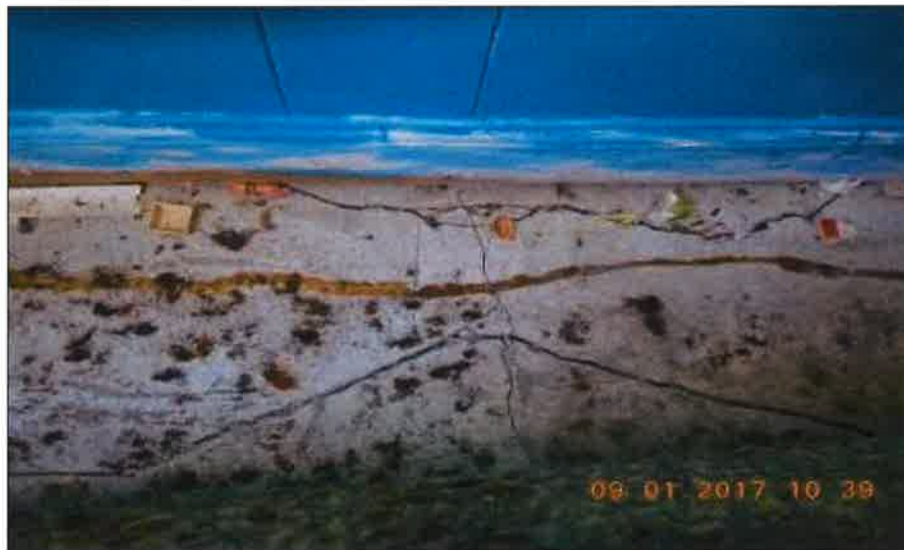
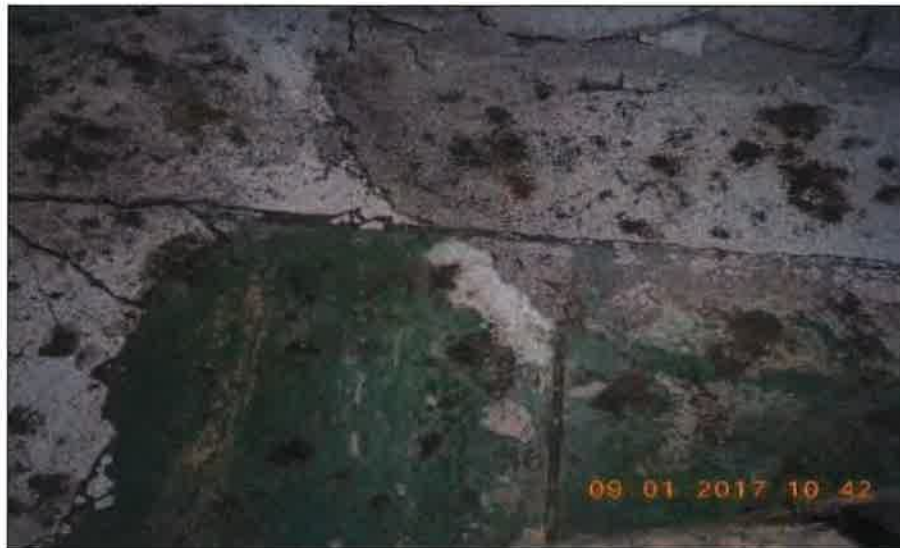
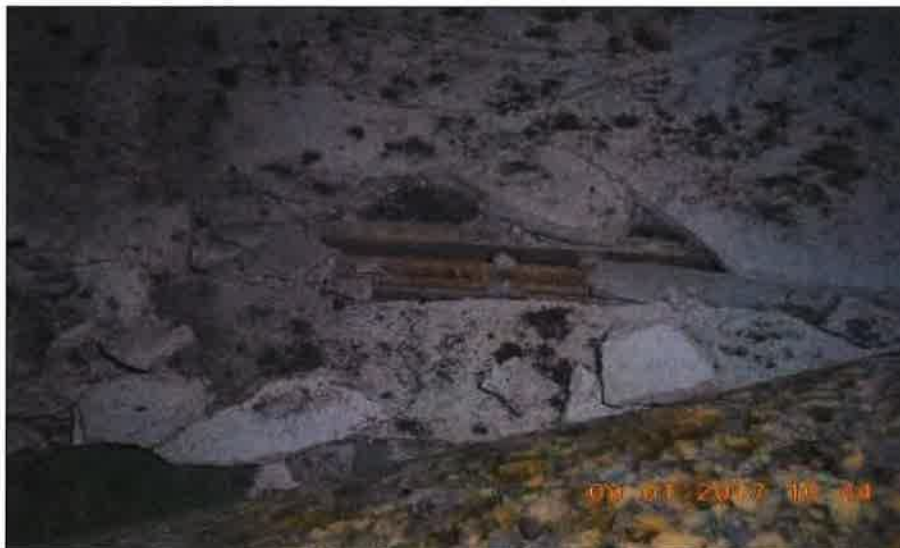
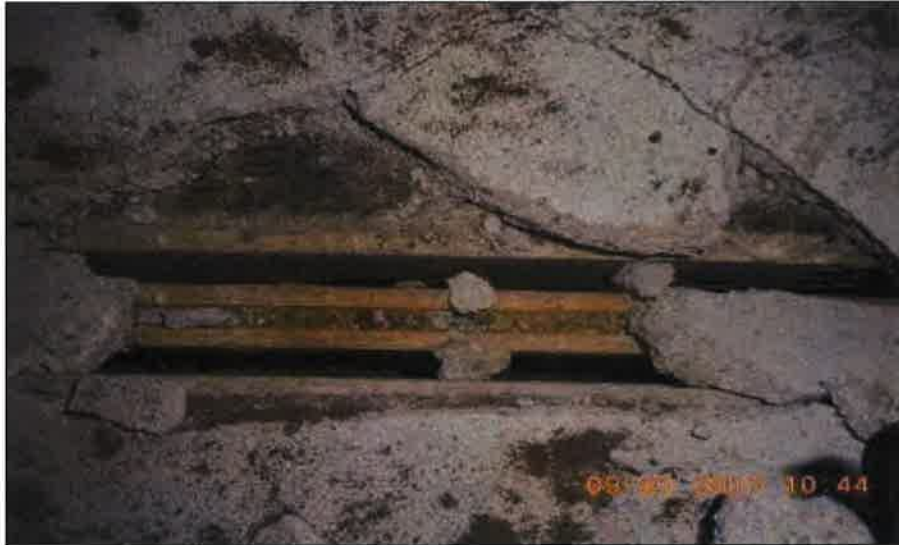
- The floor inside the residence had several areas of bowing (**Drawing Attachment B**).
- The carpet was pulled back in the son's bedroom, and the concrete under the carpet was examined. The concrete had an area where it had been patched. It was cracked and broken. Examining below the broken pieces of concrete, it was determined that the room was extended at some point and a new strip footing had been added, and there was plywood incorporated in the footing. (**Photographs 15 through 19**).

Photograph 15
Son's room.

Photograph 16
Son's room floor under the carpet.

Son's room floor under the carpet.

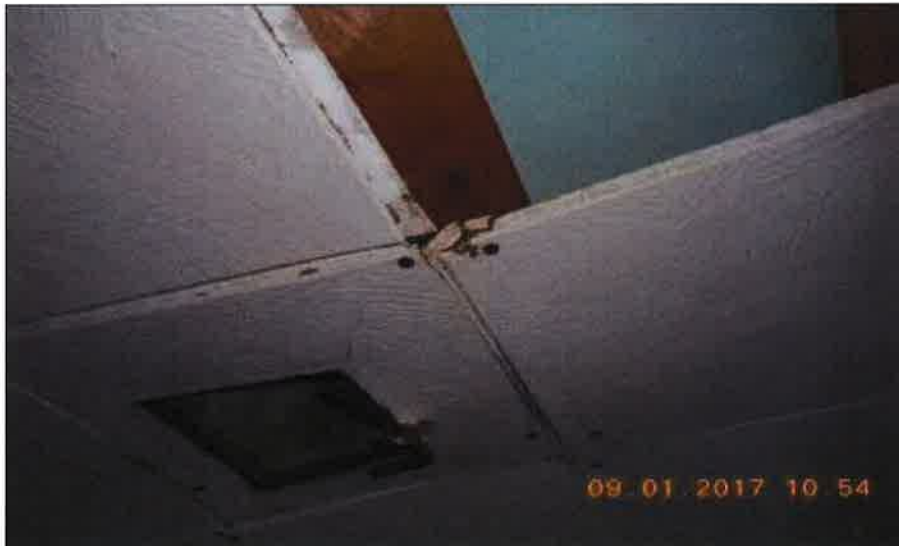
Photograph 20

- It was observed that the ceiling in the bathroom and son's bedroom had ceiling tiles that were missing. Repairs of these tiles were observed to be aged (**Photograph 20**).
- Several cracks were noticed throughout the residence. All were observed to have paint inside the cracks (**Photographs 21 through 23**).

Ceiling tiles.

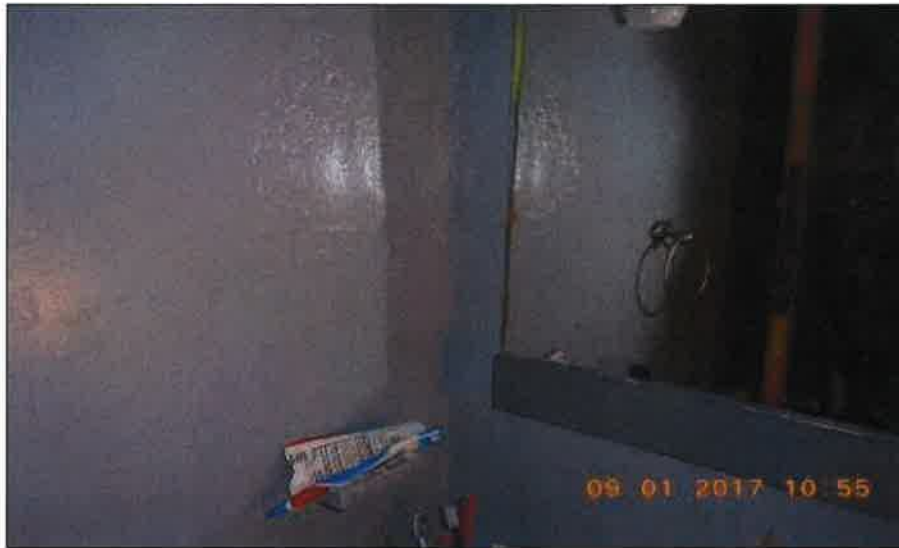
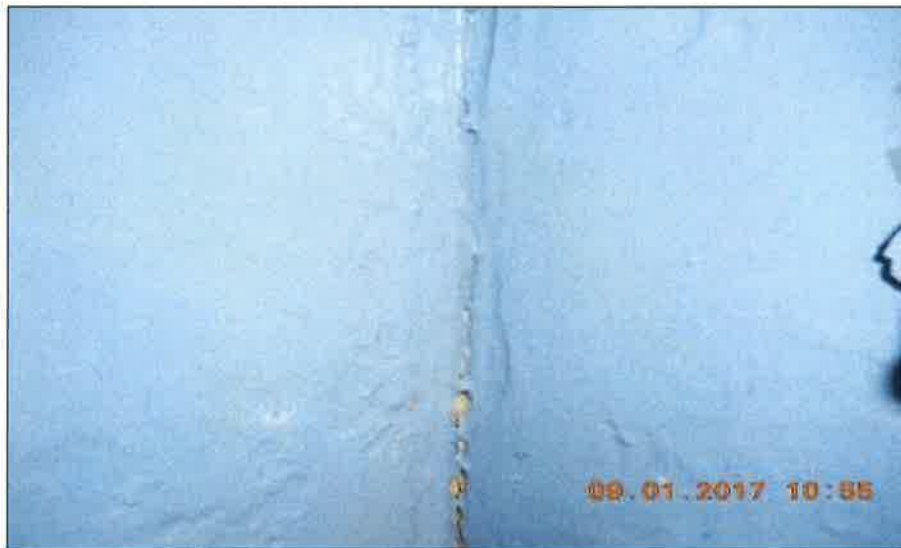
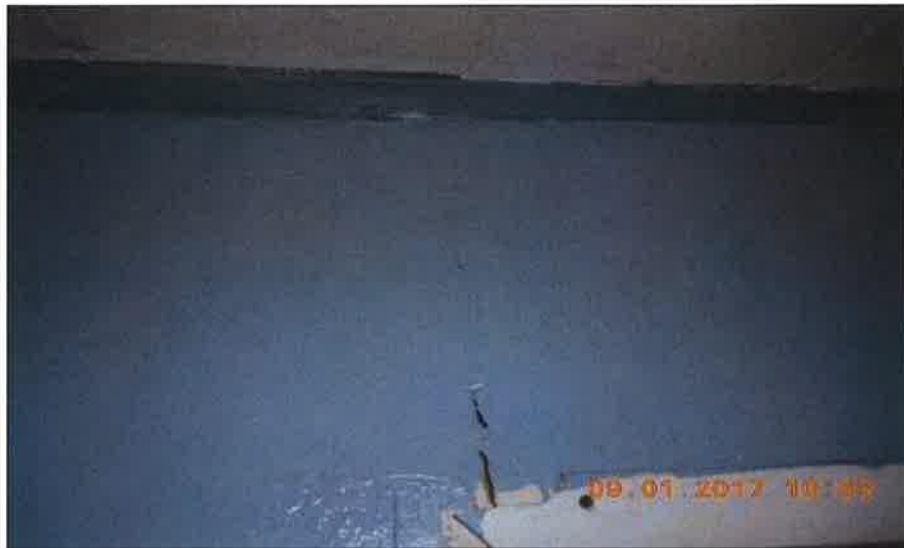
Photograph 21
Bathroom cracks.

Photograph 22
Bathroom cracks.

Photograph 23
Bathroom cracks.

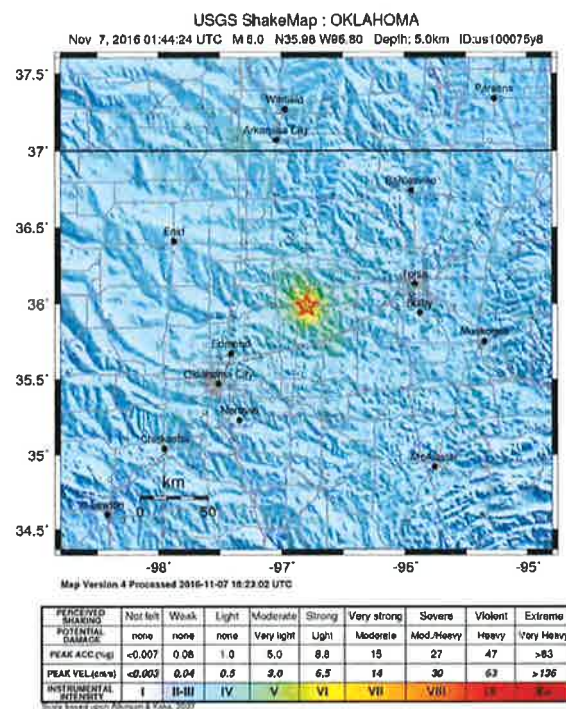
Shake Map Information

A review of the shake map on the USGS website indicated that the November 7, 2016, seismic event resulted in the following at the subject property (**Attachment C**):

- Peak Acceleration (8.8 second) of 1.0 percent of gravity.
- Peak Velocity of 6.5 centimeters per second.
- Instrumental Intensity VI.
- Instrumental intensity VI seismic events result in strong perceived shaking and light potential damage.

The magnitude 5.0 earthquake that occurred on November 7, 2016, the epicenter of which was located near the subject property, resulted in instrumental intensity VI at the subject residential property and the residence was evaluated and did not cause damage to the residential property. Structural damage is defined as displacement and/or loss of the continuity of structural members, such as columns, walls, and beams, to transmit forces from wind, gravity, or seismic forces to the foundation. No visible indications of recent structural damage were observed within the residence. The damage observed consisted of an uneven floor, fallen ceiling tiles, cracking along the base of the wall and a leaning wall.
